ASBESTOS AND LEAD-CONTAINING MATERIALS DEMOLITION SURVEY REPORT

**SAN MIGUEL FIRE DISTRICT
CREST STATION 18 AND FIRE STATION VEHICLE GARAGE
1811 SUNCREST BOULEVARD,
EL CAJON, CALIFORNIA 92021**

PROJECT NO. 119480 - AS, XRF, LS

**SURVEY DATE: FEBRUARY 6, 2024
REPORT DATE: FEBRUARY 20, 2024**

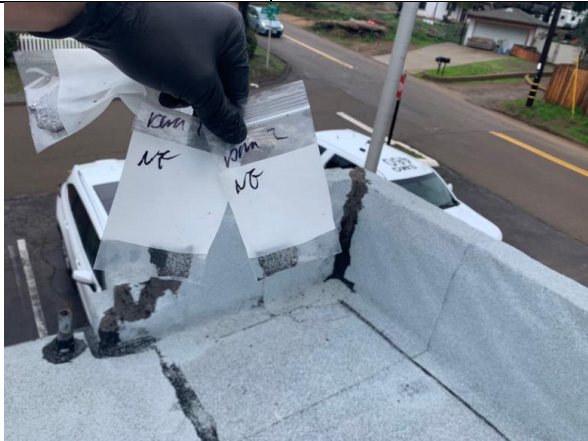
Photo of HA number 2, Sample No. 0206-02-05
0206-02-06 | Non-ACM Gray Parapet Wall, within Station 18 Roof

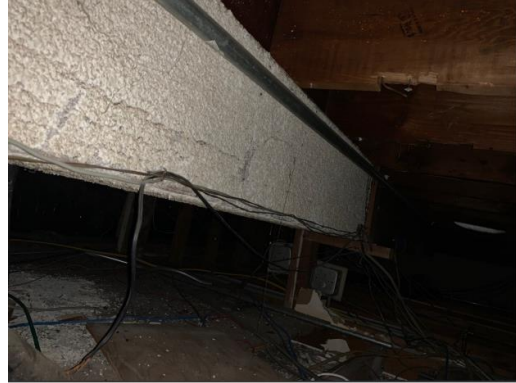
Photo of HA number 26, Sample No. 0206-26-84, 85, 86 | **ACM** White Fireproofing, within Crest Station 18 Roof

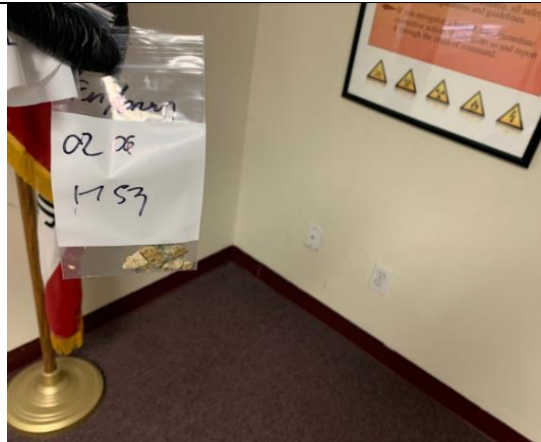
Photo of HA number 17, Sample No. 0206-17-53 | Non-ACM Orange and Green Carpet Mastic, Within Day Room

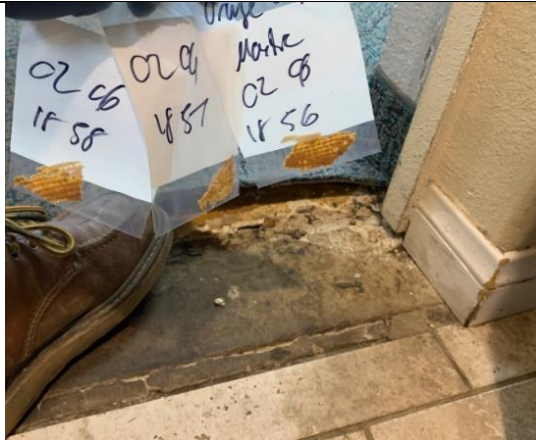
Photo of HA number 18, Sample No. 0206-18-56, 0206-18-57 & 0206-18-58 | Non-ACM Orange Carpet Mastic, within Open Room

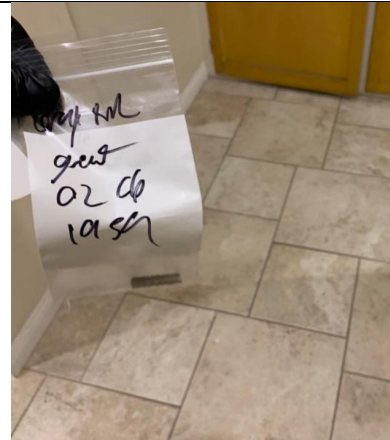
Photo of HA number 19, Sample No. 0206-19-59 | Non-ACM Gray Tile Grout, Within Hallway and Kitchen

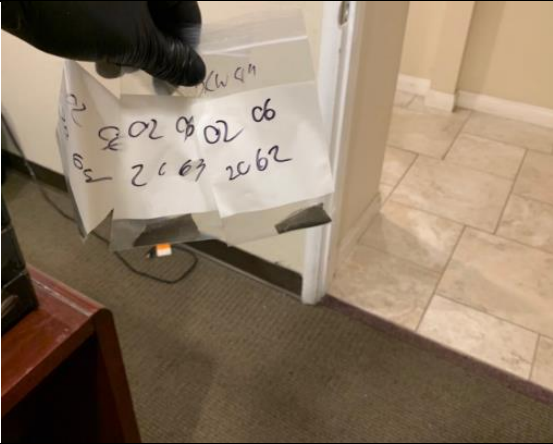
Photo of HA number 20, Sample No. 0206-20-62, 0206-20-63 & 0206-20-64 | Non-ACM Brown 4" Cove Base, within Captains Office

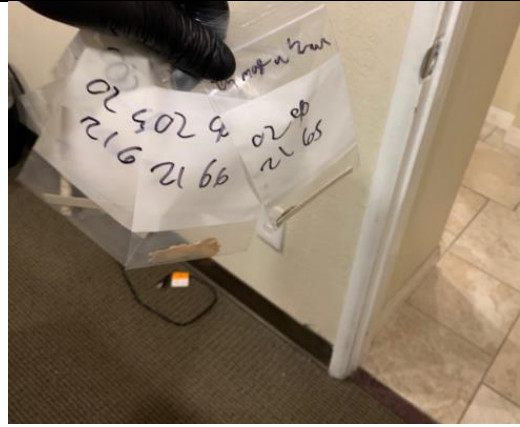
Photo of HA number 21, Sample No. 0206-21-65, 0206-21-66 & 0206-21-67 | Non-ACM White 4" Cove Base Mastic Associated with Beam, within Captains Office

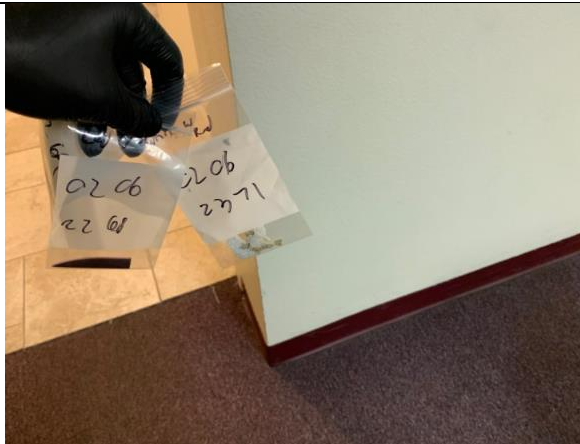
Photo of HA number 22 & 23, Sample No. 0130-17-51 | Non-ACM Red 4" Cove Base and White / Red 4" Cove Base Associated with Mastic, Within Open Room, Day Room and Bedroom 1

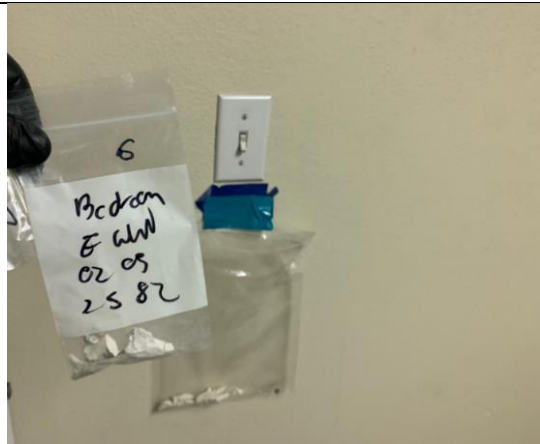
Photo of HA number 25, Sample No. 0206-25-82 | Non-ACM White Drywall and Joint Compound, Within Front Office, Captains Office, Hallway, Day Room, Bathroom 2, Bedroom 1 and Open Room

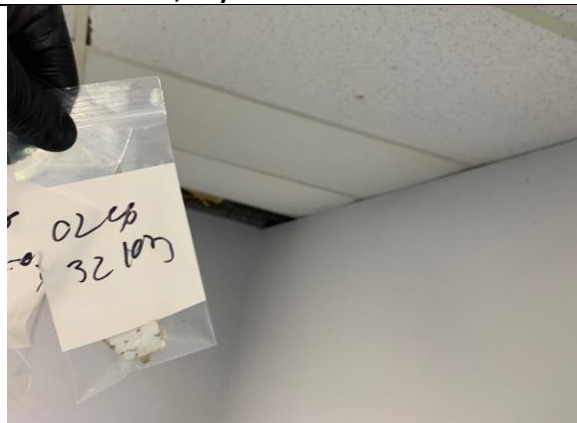
Photo of HA number 32, Sample No. 0206-32-103 | Non-ACM White 2'x4' Ceiling Tile, within Open Room

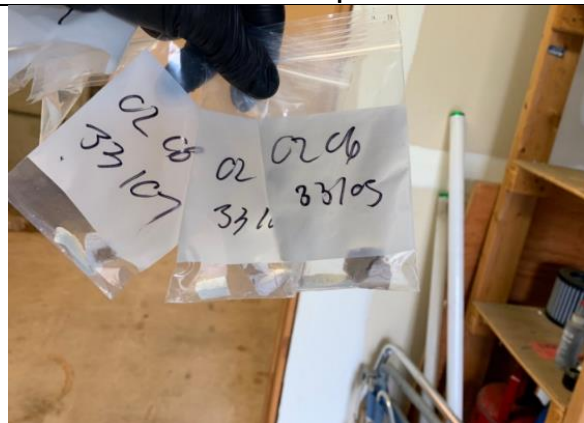
Photo of HA number 33, Sample No. 0206-33-105, 0206-33-106 & 0206-33-107 | Non-ACM White Drywall / Joint Compound (Unfinished), within Storage Room 1

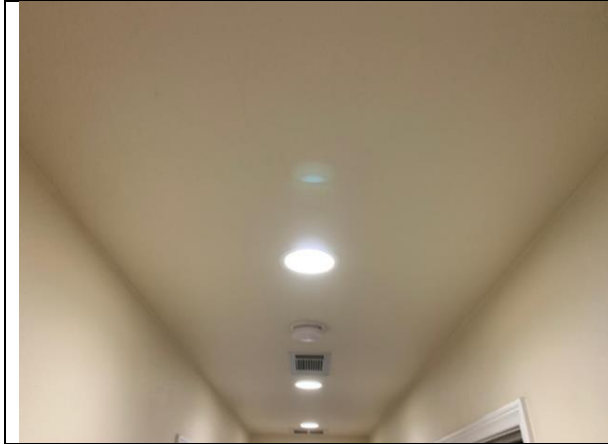
Photo of sample number 15, BDL Drywall Ceiling, Within Hallway

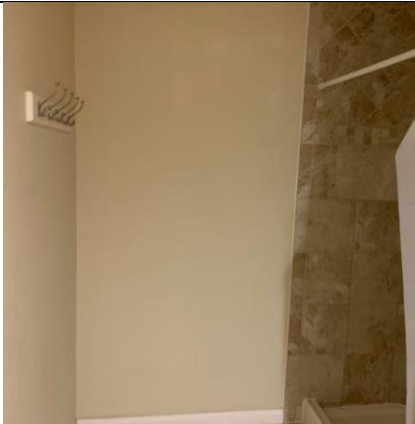
Photo of sample number 25, Non-LBP Ceramic Shower Wall, Within Bathroom

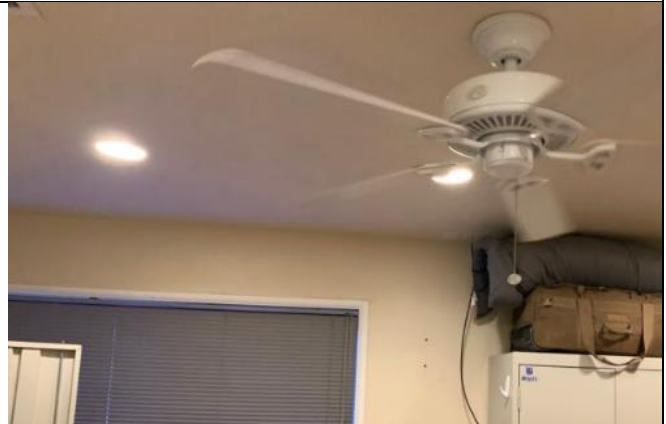
Photo of sample number 28, Non-LBP Drywall Ceiling, Within Bedroom

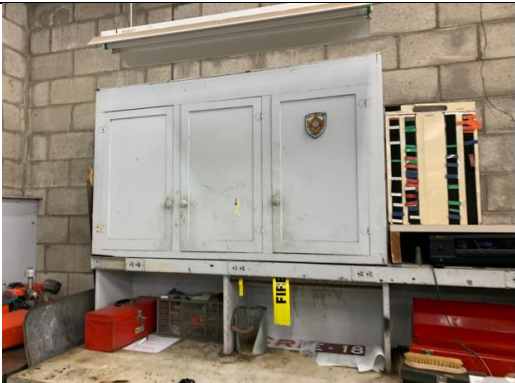
Photo of XRF sample number 4 and Paint Chip sample number 01, LBP Wood Cabinet, Within Station Garage

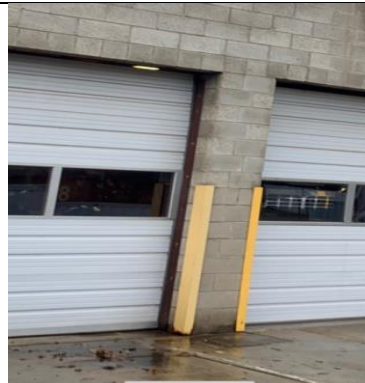
Photo of XRF sample number 11 and Paint Chip sample number 02, LBP Metal Corner Strip, Within Station Garage
